Fire at 936 Childs Point Road

**Bureau of Alcohol, Tobacco, Firearms and Explosives
Anne Arundel County Fire Department**

Executive Summary
ATF Investigation # 761010-15-0026 / AAFD Investigation # 15-017
Fire at 936 Childs Point Road, Annapolis, MD

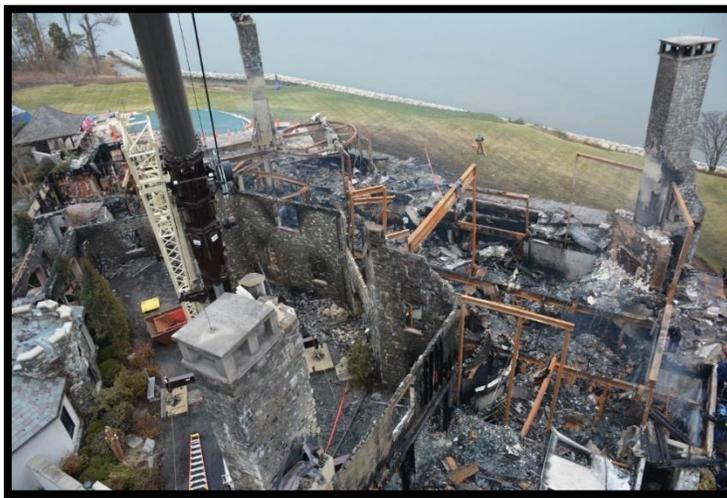
Figure 8 – Aerial view of main residence

All north facing window openings were void of windows. Additionally, the window openings above the main entrance were partially collapsed and several feet of stone rubble was found on the front stoop.

Further examination revealed the north walls of the east garage were intact and the two garage doors appeared to be in the down position; however, those garage doors were mostly collapsed. Investigators also observed the roof system above the arcade (breezeway) was completely consumed from the east garage to the guesthouse. There was also a heavily fire-damaged minivan parked under the arcade.

Investigators continued the exterior damage assessment to the east exterior and observed that the east exterior stucco walls of the east garage and Spa Room were mostly intact. Further examination showed that the screened in porch had been completely consumed or collapsed. The exterior examination continued to the south exterior where investigators observed complete collapse and/or consumption of the south wall. Investigators further noted that a steel column and beam header in the area of the Dining Room near the south exterior wall was leaning into the structure to the north.

As investigators continued to the west exterior of the residence they noted that the southwest stone corner and fireplace chimney was intact. Additionally, investigators observed the west facing exterior stucco wall had collapsed and a large section of it was on top of the west garage debris field. Examination of the west exterior stairwell revealed pieces of the exterior stucco wall had also collapsed into that area. There was also a steel column and beam header in the area of Guest Bedroom #1 exposed near the west exterior wall.

Investigators were unable to assign any meaningful significance to macro fire patterns due to the extensive damage observed to all major structural members throughout the building. Therefore, investigators subsequently attempted to use micro, or local, fire damage comparisons in an effort to identify potential directional fire patterns.

An aerial view highlighted the vast devastation to the structure as depicted below in Figure 8.

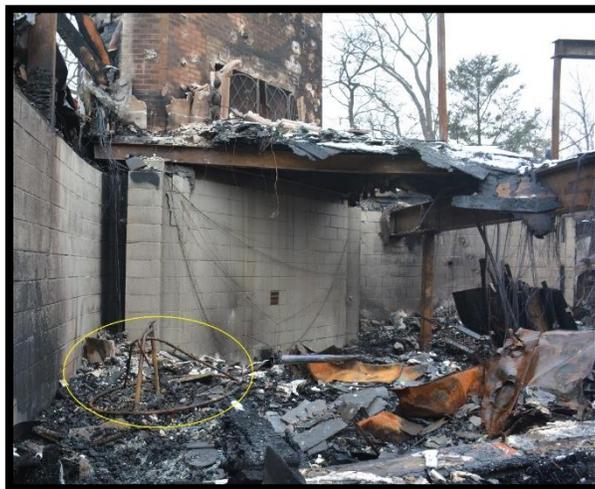
Figure 9 – Location of Christmas tree stand

During initial damage assessment, investigators also discovered remnants of a metal Christmas tree stand in the Great Room debris field. The stand was near the top of the debris with a burned stump still in the bottom screw of the stand. The Christmas tree stand stood approximately 2 feet high and the diameter of its base spanned approximately 4 feet. The charred tree stump remnants were approximately 6" wide and 10" high. The metal stand was located just off the south wall, east of the Great Room fireplace, as depicted below in Figure 9.

Investigators noted that the Christmas tree area was a potential fire origin, so that area was taped off for later excavation.

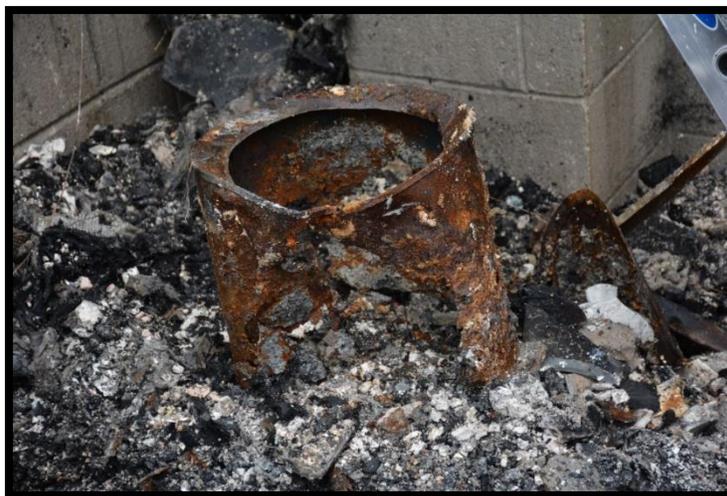
Figure 10 – Damaged ceiling light can

As investigators excavated immediately east of the fireplace and adjacent to the south basement wall, they located a ceiling can light that exhibited more oxidation and mass loss than any other can light located in the Great Room debris, as depicted below in Figure 10. Additional excavation within this general vicinity also revealed a metal door frame for the south exterior patio doors.

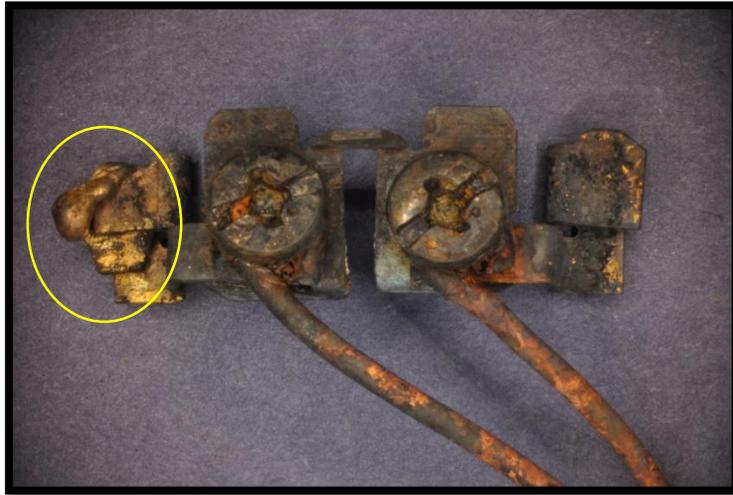
Figure 11 – Plug blade with localized melting

Further analysis was conducted on the floor duplex receptacle. The receptacle was mounted in a metal outlet box with a brass cover plate with hinged covers over the receptacles. The outlet box, cover plate and receptacle mounting yoke were intact with no evidence of electrical activity observed. The receptacle power rails were present within the outlet box, attached to two sets of conductors. The four receptacle screw terminals were observed to be intact. Three of the blade receptors were intact. The fourth blade receptor was observed to be melted. The remnants of an attachment plug blade was present in the receptor; it was observed to be melted. A second attachment plug blade was present within the outlet box. A rounded globule of melted material was present at the top of the plug blade, as depicted below in Figure 11.

The damage to the receptacle power rail and attachment plug blades was highly localized. Other brass components in the vicinity with less mass, such as the ground pin contacts, were observed to be intact. The possibility of failure of the connection between the blade receptor and attachment plug blade or failure of an internal connection within the plug assembly resulting in the production of heat due to a resistive connection cannot be precluded.

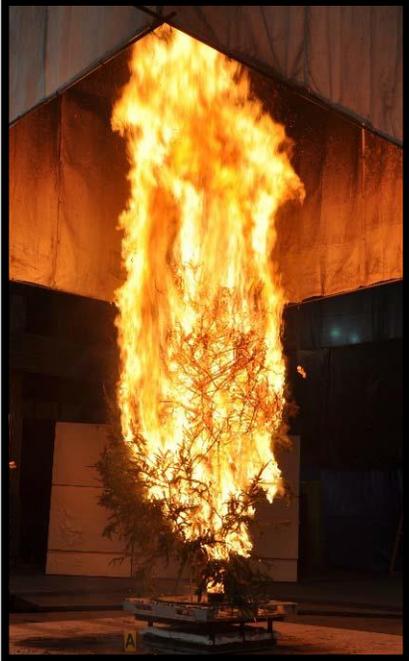
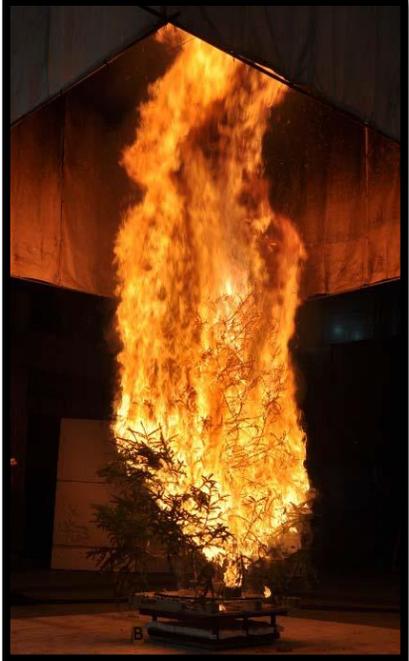
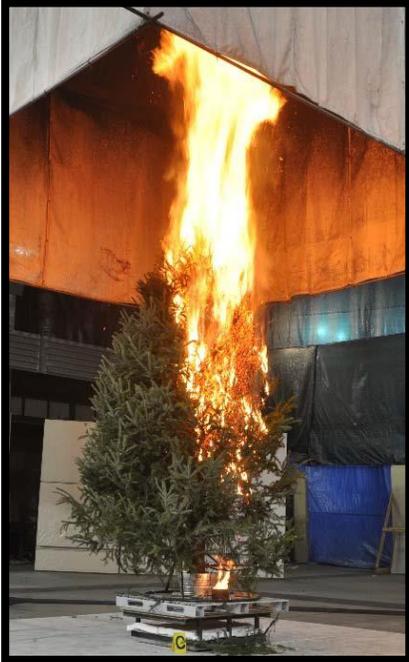
Figure 14, Figure 15 and Figure 16 depict the fire development around the time of peak burning for each of the three trees. The Heat Release Rate from each tree was assessed over the duration of the test.

For Tree A & Tree B, the peak heat flux at a distance of 10 ft. exceeded 10 kW/m². Ordinary combustibles such as upholstered furniture would be expected to be ignited by this exposure with consideration of the burning embers observed to float down from all three trees.

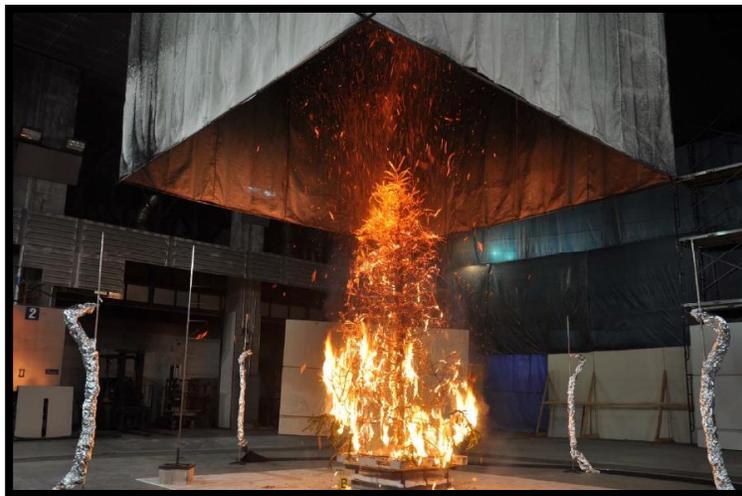
Figure 18 – Burning embers floating down late in test

From the tests, the shape of the fire was approximated as a cylinder, with an estimated flame height of approximately double the height of the tree. Burning embers were also observed to float down from each tree and were particularly prevalent as they began to burn out, as depicted in Figure 18.

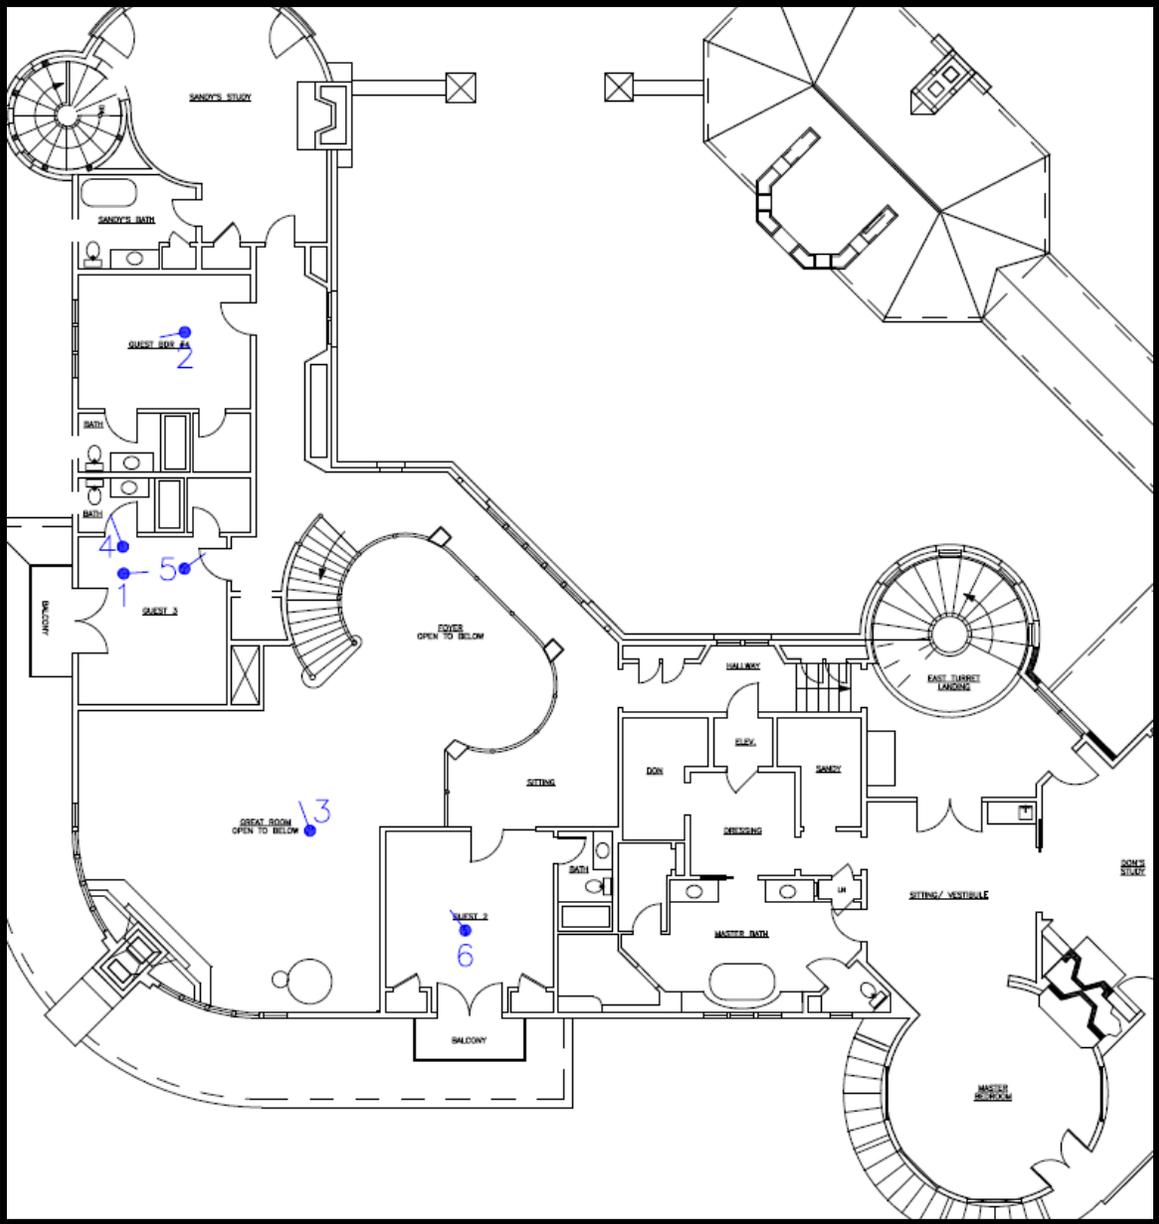
Attachment A – Recovery Location of Victims

The Office of the Chief Medical Examiner positively identified Victim # 1 as Wesley Boone (OCME Case # 15-00769). Wesley was recovered in the collapsed debris of Guest Bedroom # 3 (see Attachment A). The Medical Examiner's report advised that examination of the victim revealed no obvious non-thermal abnormalities and there was no evidence of antemortem injury. The manner of death was ruled Accidental and the cause of death was ruled to be smoke inhalation and thermal injury.

The Office of the Chief Medical Examiner positively identified Victim # 2 as Charlotte Boone (OCME Case # 15-00764). Charlotte was recovered in the collapsed debris of Guest Bedroom # 4 (see Attachment A). The Medical Examiner's report advised that examination of the victim revealed no obvious non-thermal abnormalities and there was no evidence of antemortem injury. The manner of death was ruled Accidental and the cause of death was ruled to be smoke inhalation and thermal injury.

The Office of the Chief Medical Examiner positively identified Victim # 3 as Donald Pyle (OCME Case # 15-00800). Donald was recovered in the collapsed debris of the Great Room in close proximity to the area where the family's Christmas tree had stood (see Attachment A). The Medical Examiner's report advised that examination of the victim revealed no obvious non-thermal abnormalities and there was no evidence of antemortem injury. The manner of death was ruled Accidental and the cause of death was ruled to be smoke inhalation and thermal injury.

The Office of the Chief Medical Examiner positively identified Victim # 4 as Kaitlyn Boone (OCME Case # 15-00801). Kaitlyn was recovered in the collapsed debris of Guest Bedroom # 3 (see Attachment A). The Medical Examiner's report advised that examination of the victim revealed no obvious non-thermal abnormalities and there was no evidence of antemortem injury. The manner of death was ruled Accidental and the cause of death was ruled to be smoke inhalation and thermal injury.

The Office of the Chief Medical Examiner positively identified Victim # 5 as Sandra Pyle (OCME Case # 15-00859). Sandra was recovered in the collapsed debris of Guest Bedroom # 3 (see Attachment A). The Medical Examiner's report advised that examination of the victim revealed no obvious non-thermal abnormalities and there was no evidence of antemortem injury. The manner of death was ruled Accidental and the cause of death was ruled to be smoke inhalation and thermal injury.

The Office of the Chief Medical Examiner positively identified Victim # 6 as Alexis Boone (OCME Case # 15-00953). Alexis was recovered in the collapsed debris of Guest Bedroom # 2 (see Attachment A). The Medical Examiner's report advised that examination of the victim revealed no obvious non-thermal abnormalities and there was no evidence of antemortem injury. The manner of death was ruled Accidental and the cause of death was ruled to be smoke inhalation and thermal injury.
