Fire at 936 Childs Point Road

**Bureau of Alcohol, Tobacco, Firearms and Explosives
Anne Arundel County Fire Department**

Executive Summary
ATF Investigation # 761010-15-0026 / AAFD Investigation # 15-017
Fire at 936 Childs Point Road, Annapolis, MD

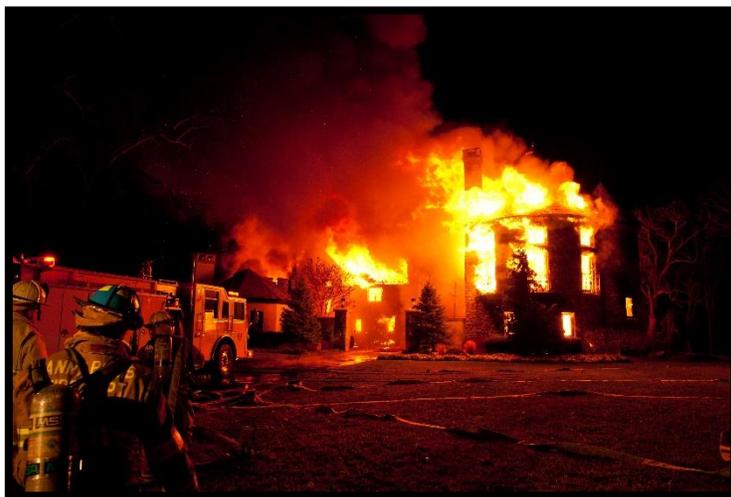
Figure 1 – Fire suppression activity

- 4:13:24am AAFD's Fire and Explosives Investigation Unit personnel arrive on location.
- 4:31:24am Fourth alarm requested, bringing a total of 85 firefighters to the scene from Anne Arundel County, Annapolis City and the Naval Academy (Figure 1).

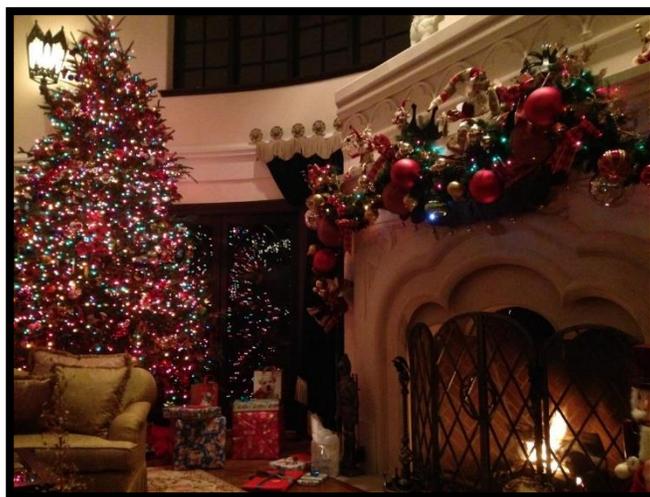
Figure 7 – Decorations in Great Room

The Pyle’s residence had two Christmas trees, a 15-foot Fraser fir tree and a 7-foot Douglas fir tree. The larger tree was kept in the Great Room and the smaller tree was placed in the bar area. The Fraser fir tree in the Great Room is depicted below in Figure 7.

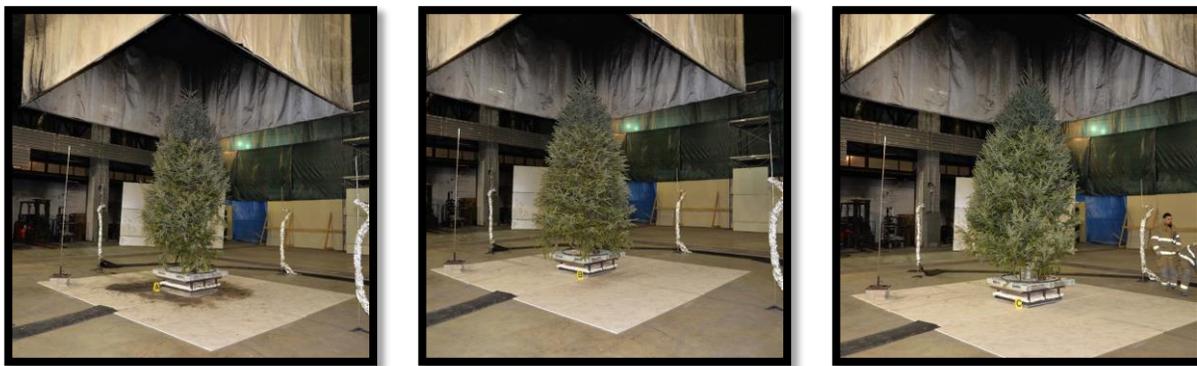
Figure 12 – Trees under Fire Product Collector

Each of the three trees was positioned under a 4 megawatt Fire Product Collector in the ATF Fire Research Lab's Medium Burn Room (Figure 12).

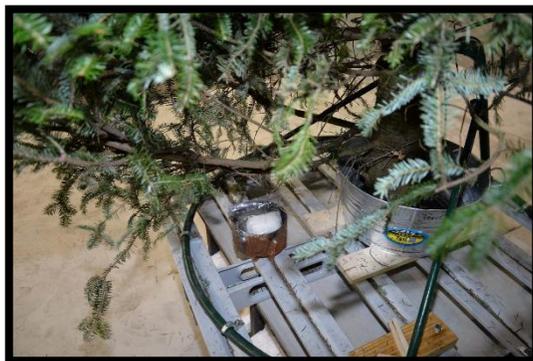
Figure 13 – Ignition package

The trees were then exposed to an open flame from an ignition package placed under the tree (Figure 13). The ignition package had burning characteristics similar to that of a small wastebasket and a burn duration of approximately 10 minutes.
